# **HYDROGEOMORPHIC EVALUATION OF ECOSYSTEM RESTORATION AND MANAGEMENT OPTIONS FOR MONTE VISTA NATIONAL WILDLIFE REFUGE**

**Greenbrier Wetland Services  
Report 13-02**

**February 2013**

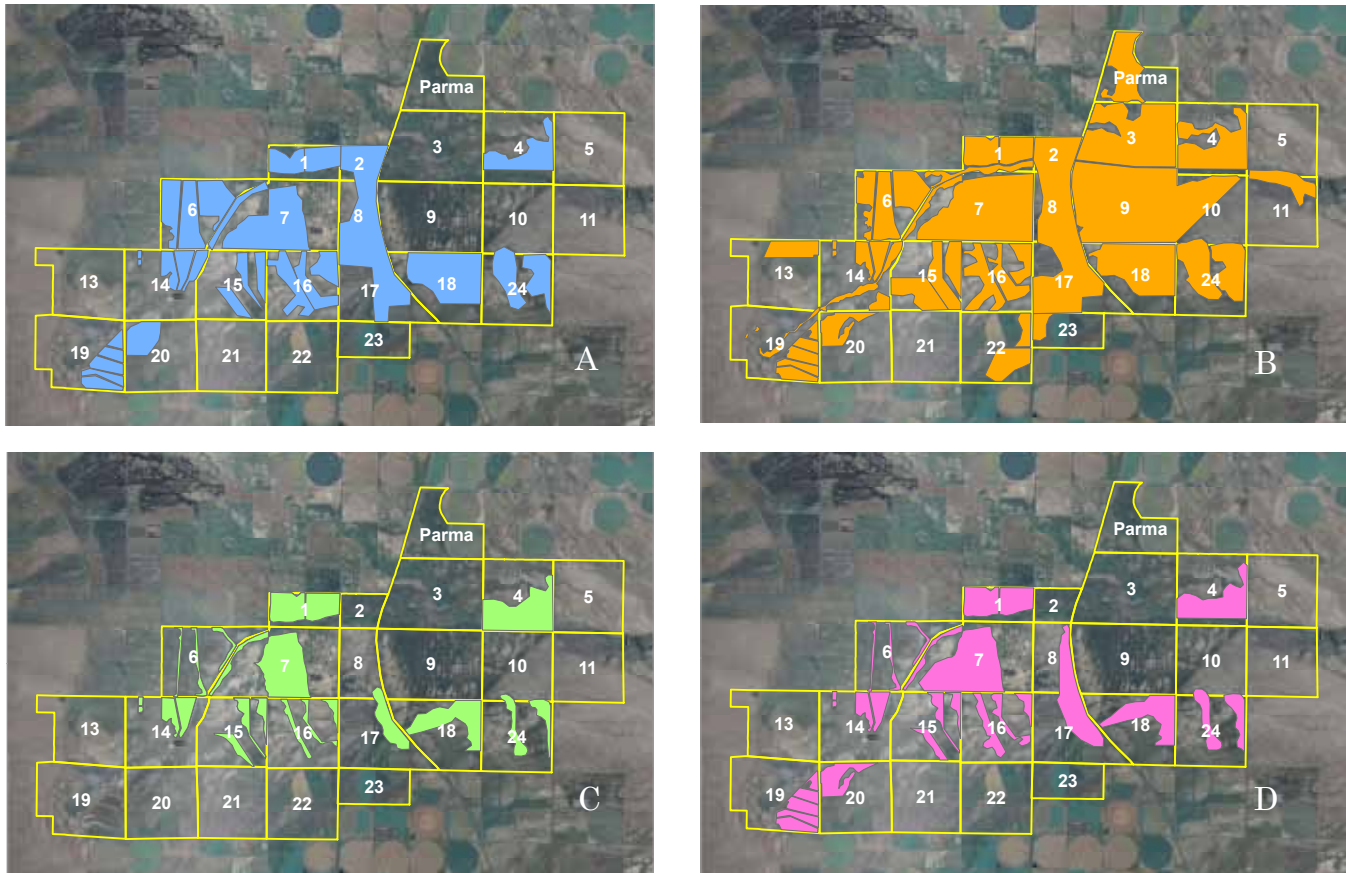
Figure 22. Water management strategies for Monte Vista National Wildlife Refuge: a) Feb-Mar, b) April to mid-June, c) mid-June to August, and d) Sept-Oct (modified from Striffler 2012).

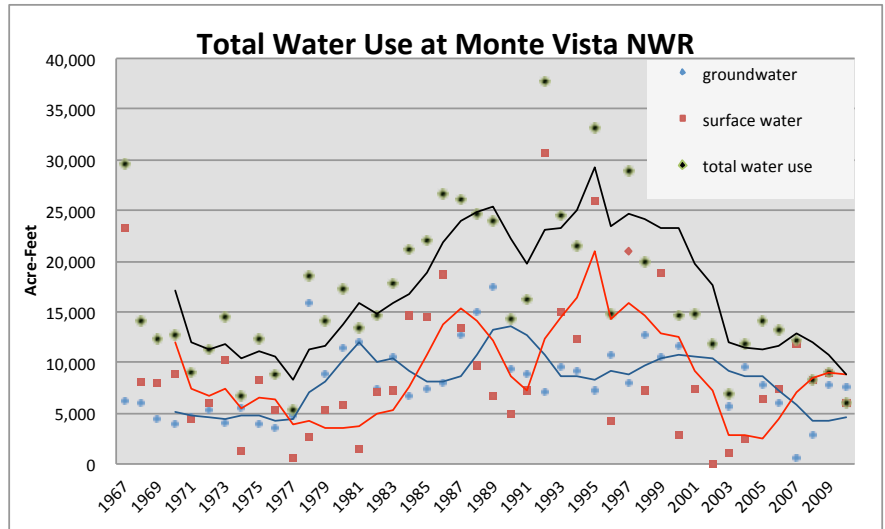
Figure 23. Total water use at Monte Vista National Wildlife Refuge 1967-2009 (from Striffler 2012).

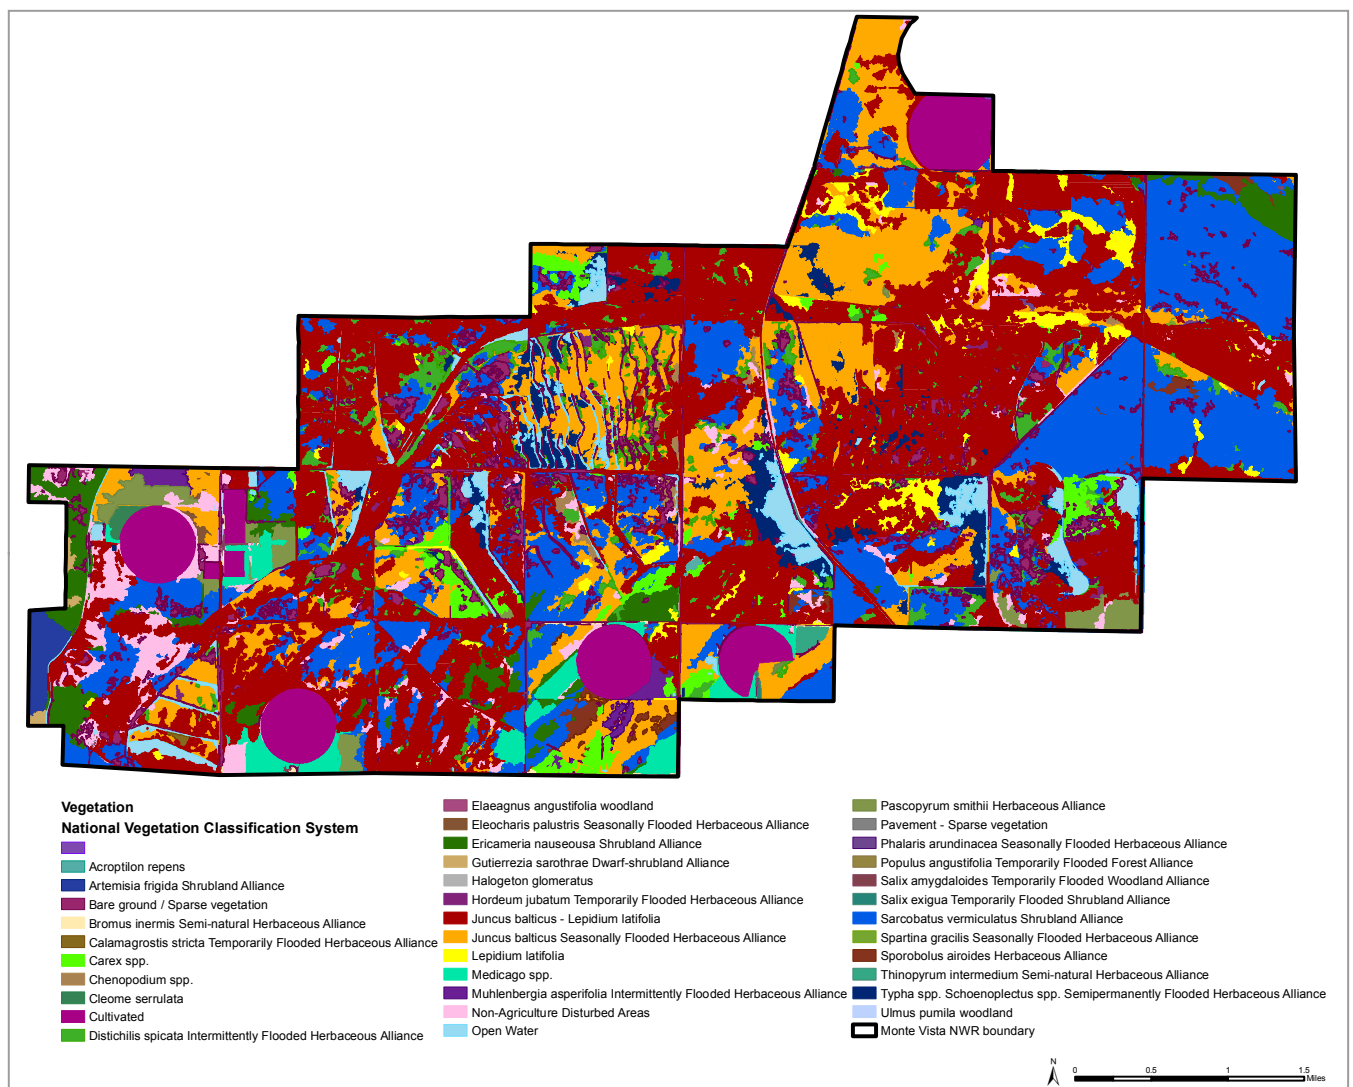
Figure 24. 2005 National vegetation classification system map of vegetation alliances on Monte Vista National Wildlife Refuge.

establishment, the relatively consistent annual water regime management (flooding) among management units, and clearing of shrubland for croplands greatly altered the vegetation community/habitat composition on Monte Vista NWR since its establishment. Major modifications/degradations included a major reduction in the extent and composition of salt desert shrub habitat and a shift in remnant shrubland community composition toward the invasive weed, tall whitetop, and wetland vegetation, especially baltic rush (comparison of habitat areas on Fig. 16 vs. Fig. 24). Currently about 24% of the refuge is in salt desert shrub habitat, which

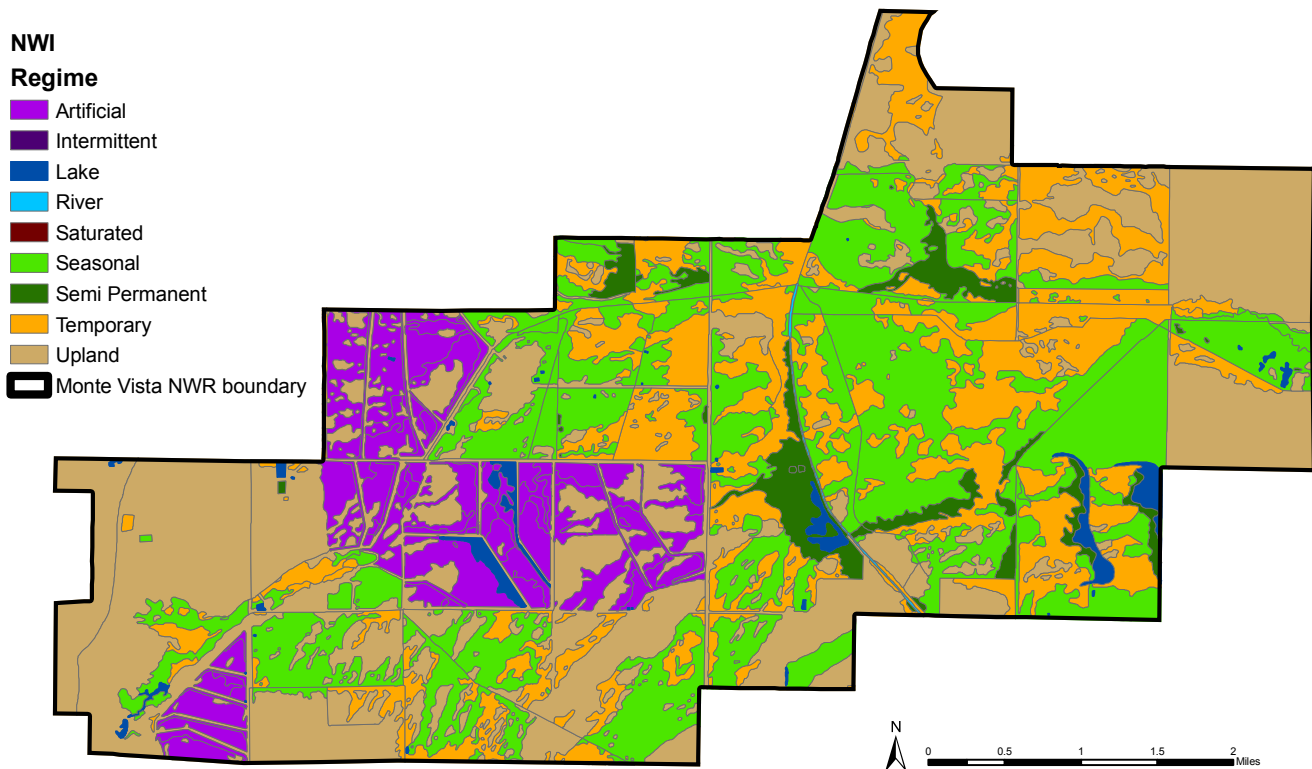
Figure 25. National wetland inventory of wetland classification types on Monte Vista National Wildlife Refuge.

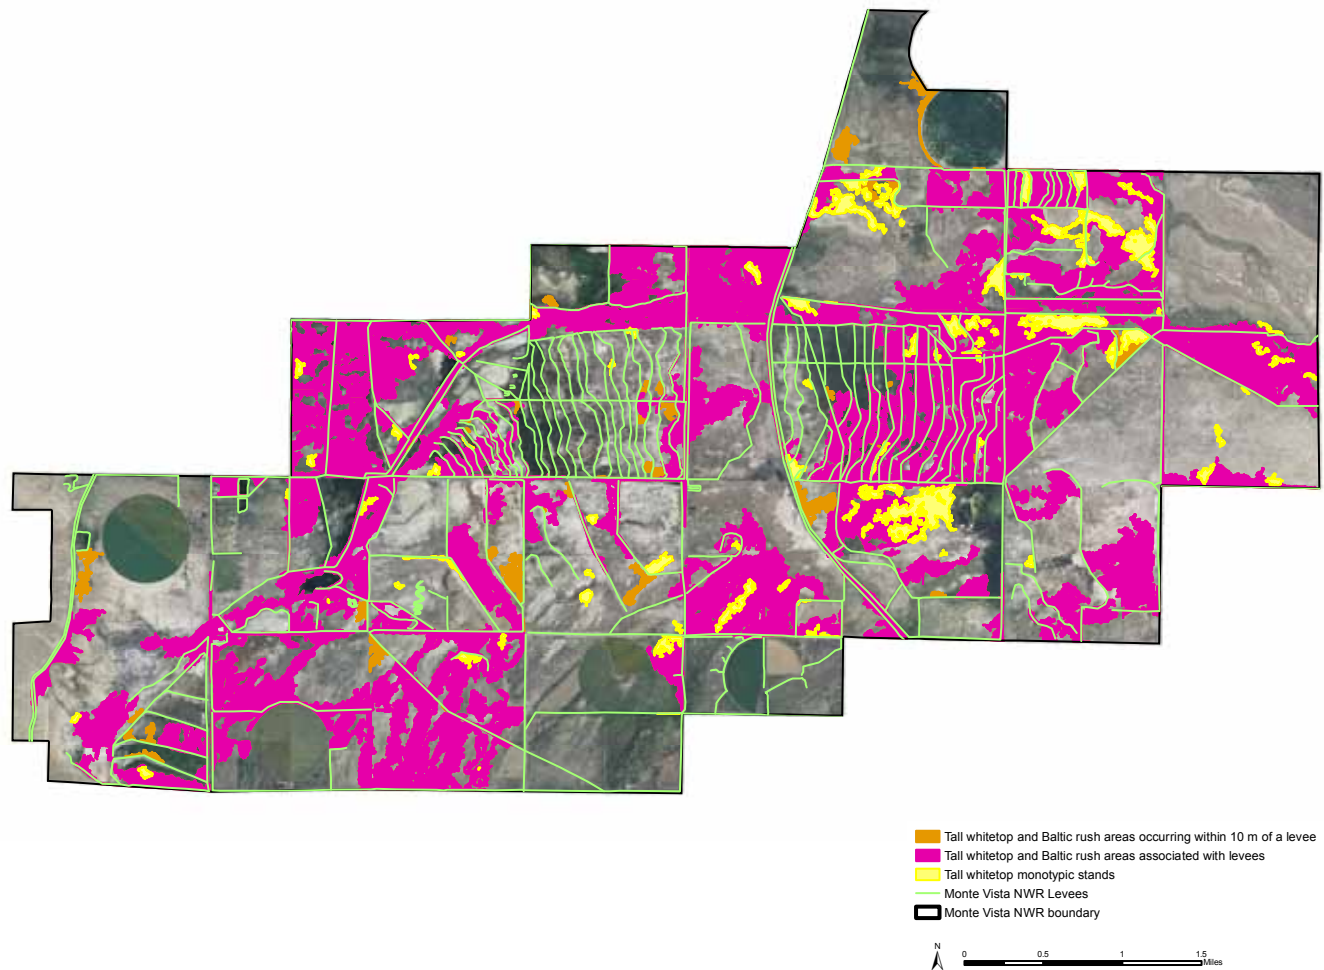
Figure 26. General location of tall whitetop and baltic rush on Monte Vista National Wildlife Refuge.

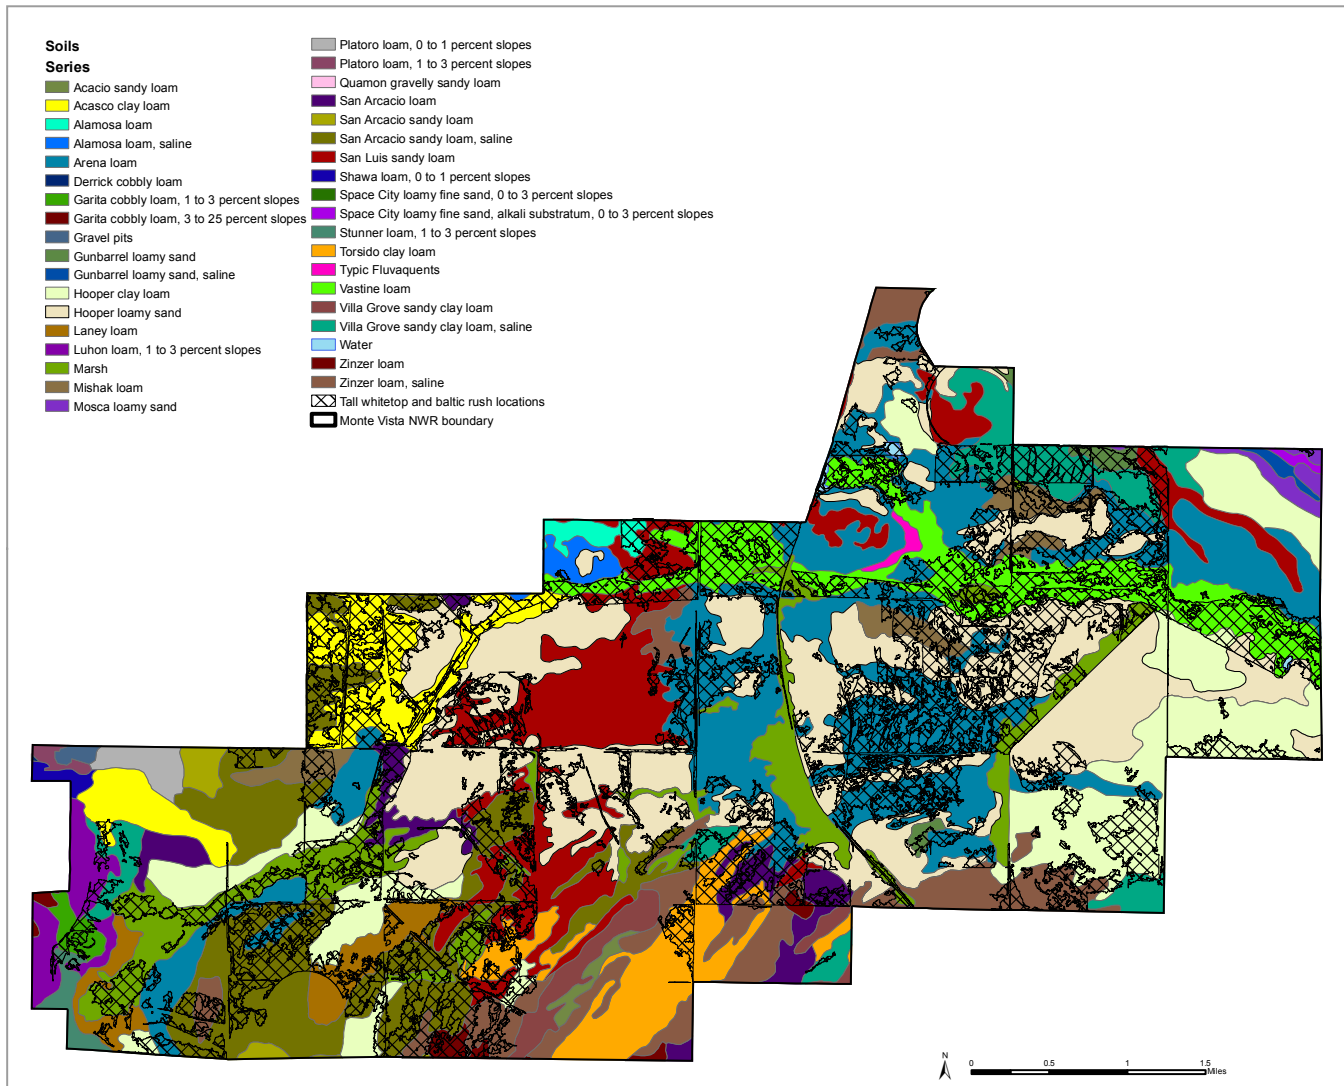
Figure 27. Location of tall whitetop and baltic rush on Monte Vista National Wildlife Refuge in relationship to soil type.

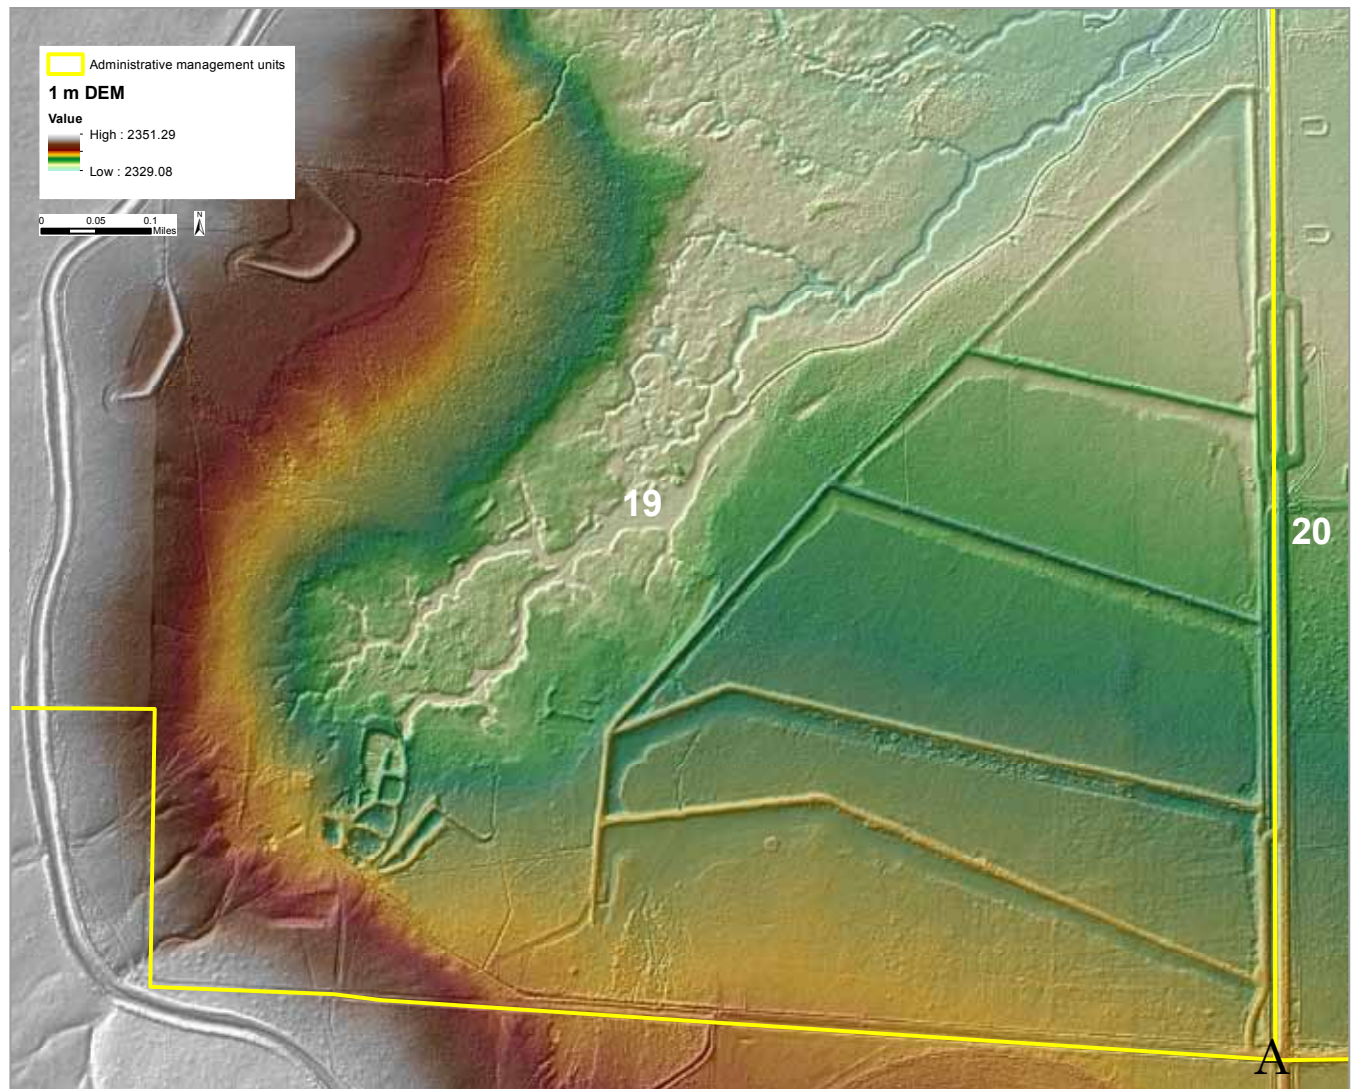
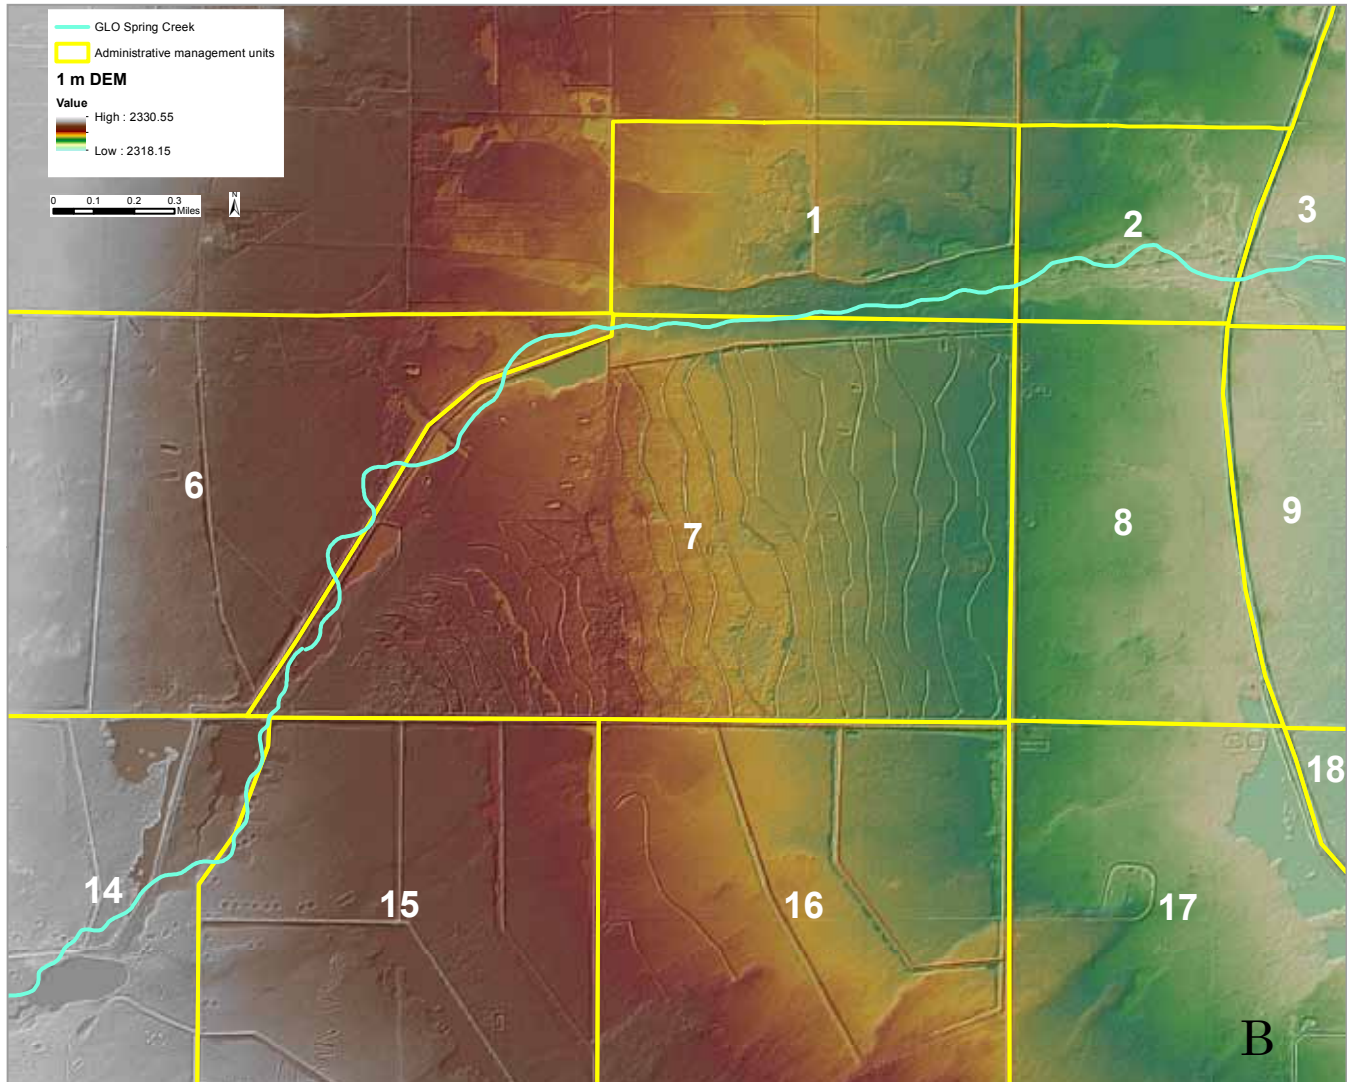
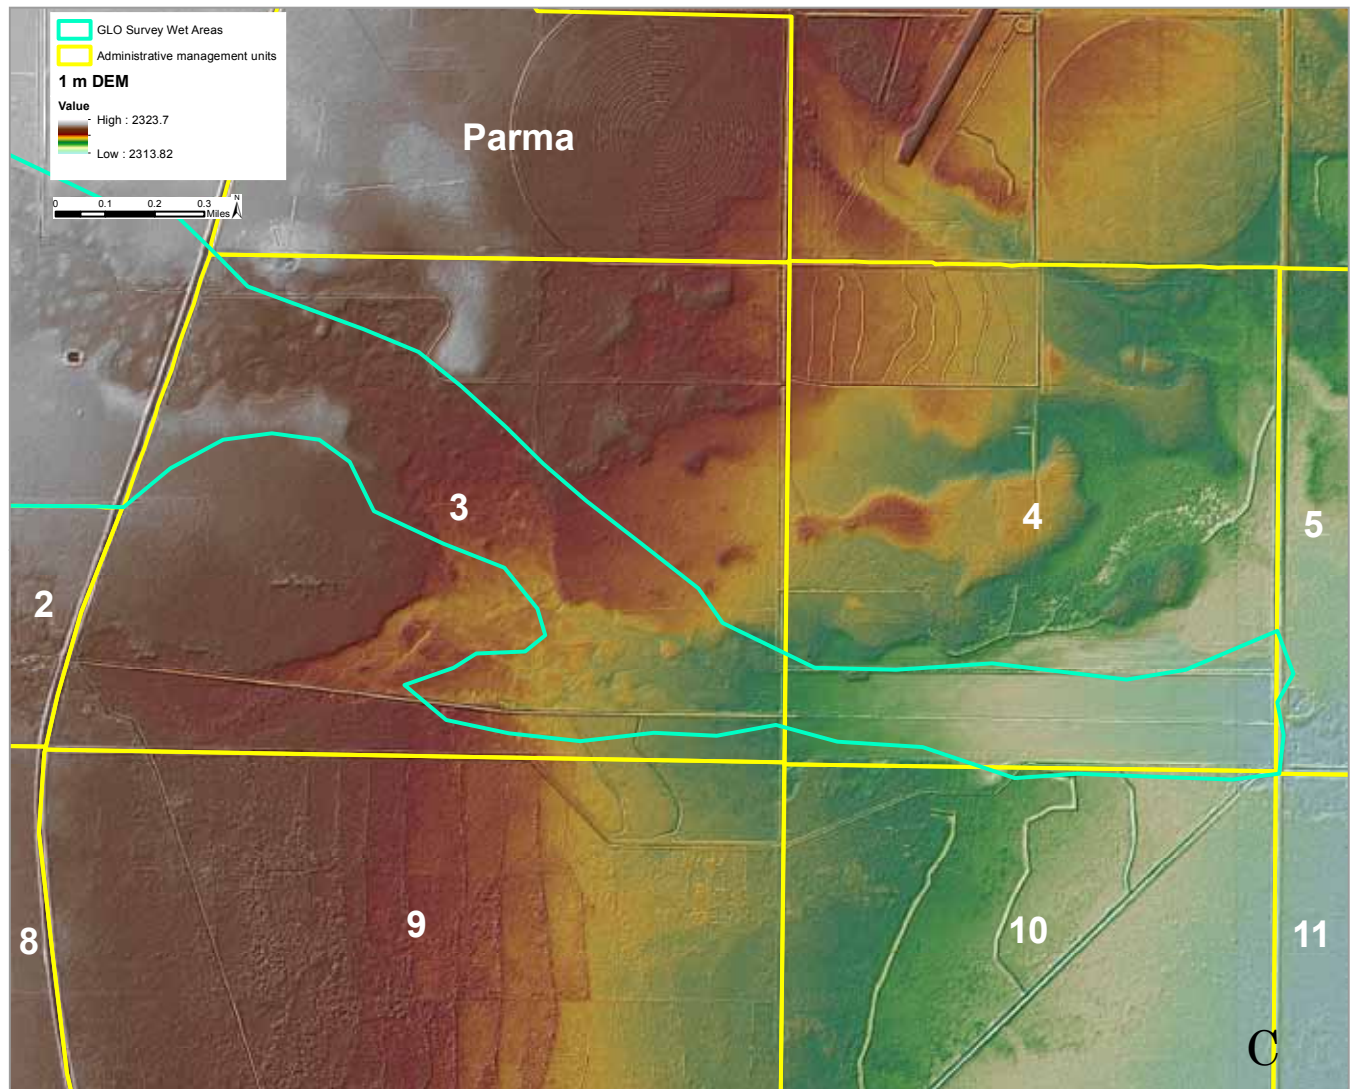
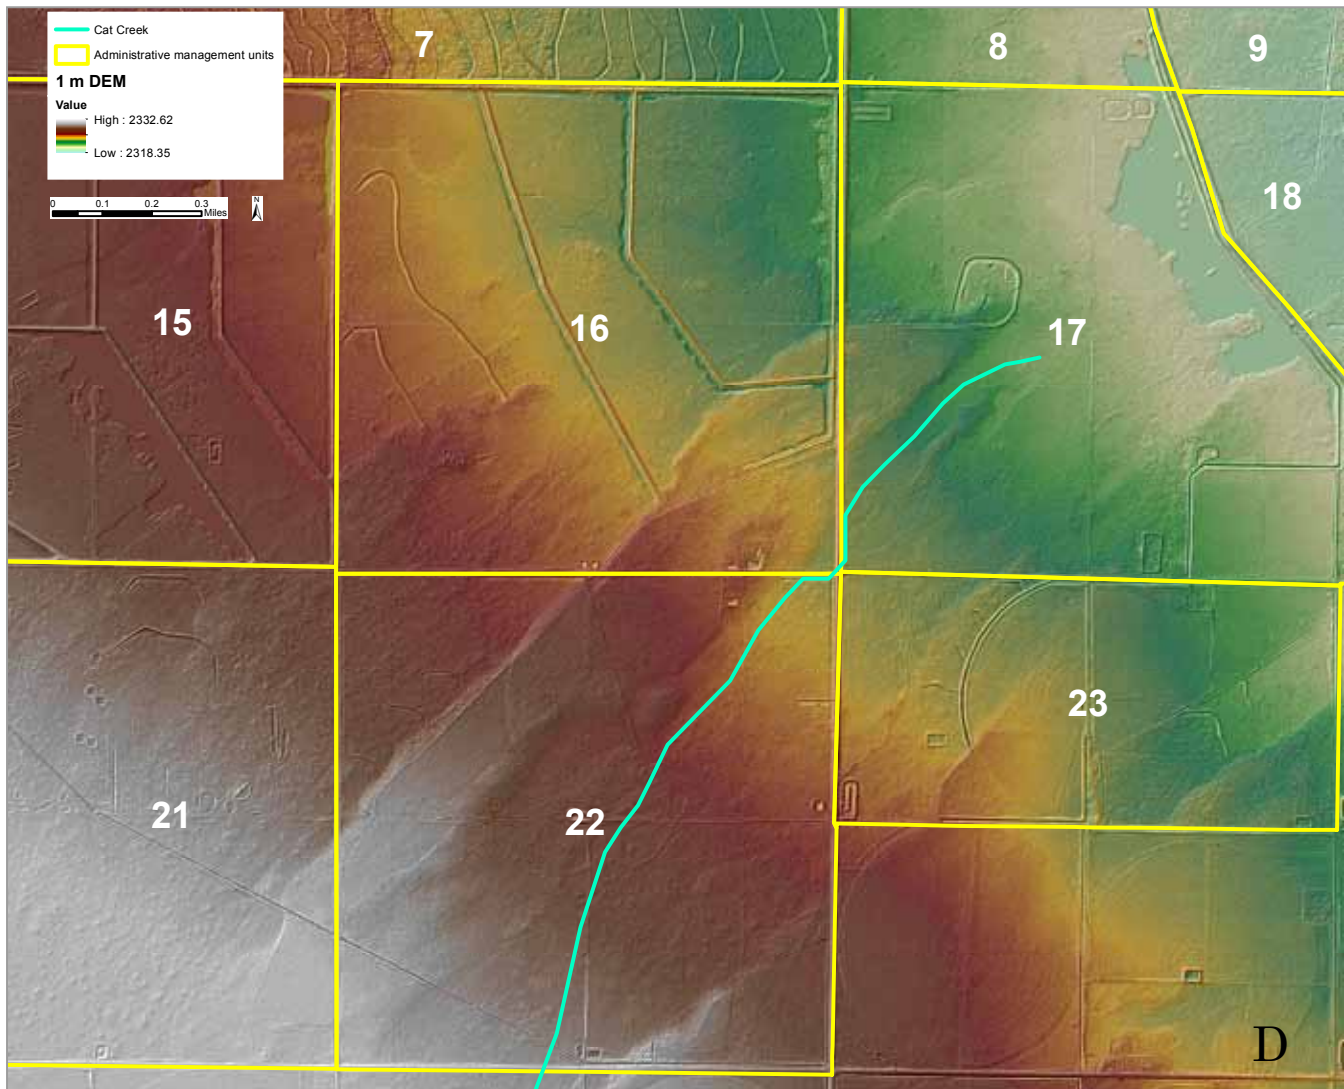
Figure 32. Potential restoration locations to restore flow patterns in former creeks channels on the Monte Vista NWR in relation to elevations changes: a) Spring Creek head in Unit 19 flowing to the northeast, b) Spring Creek prior to its convergence with Rock Creek in Units 14, 6, 7, and 1, c) the confluence area of Spring and Rock Creeks in Units 3, 4, and 5, and d) the old Cat Creek corridor in Units 16, 17, 22, and 23.

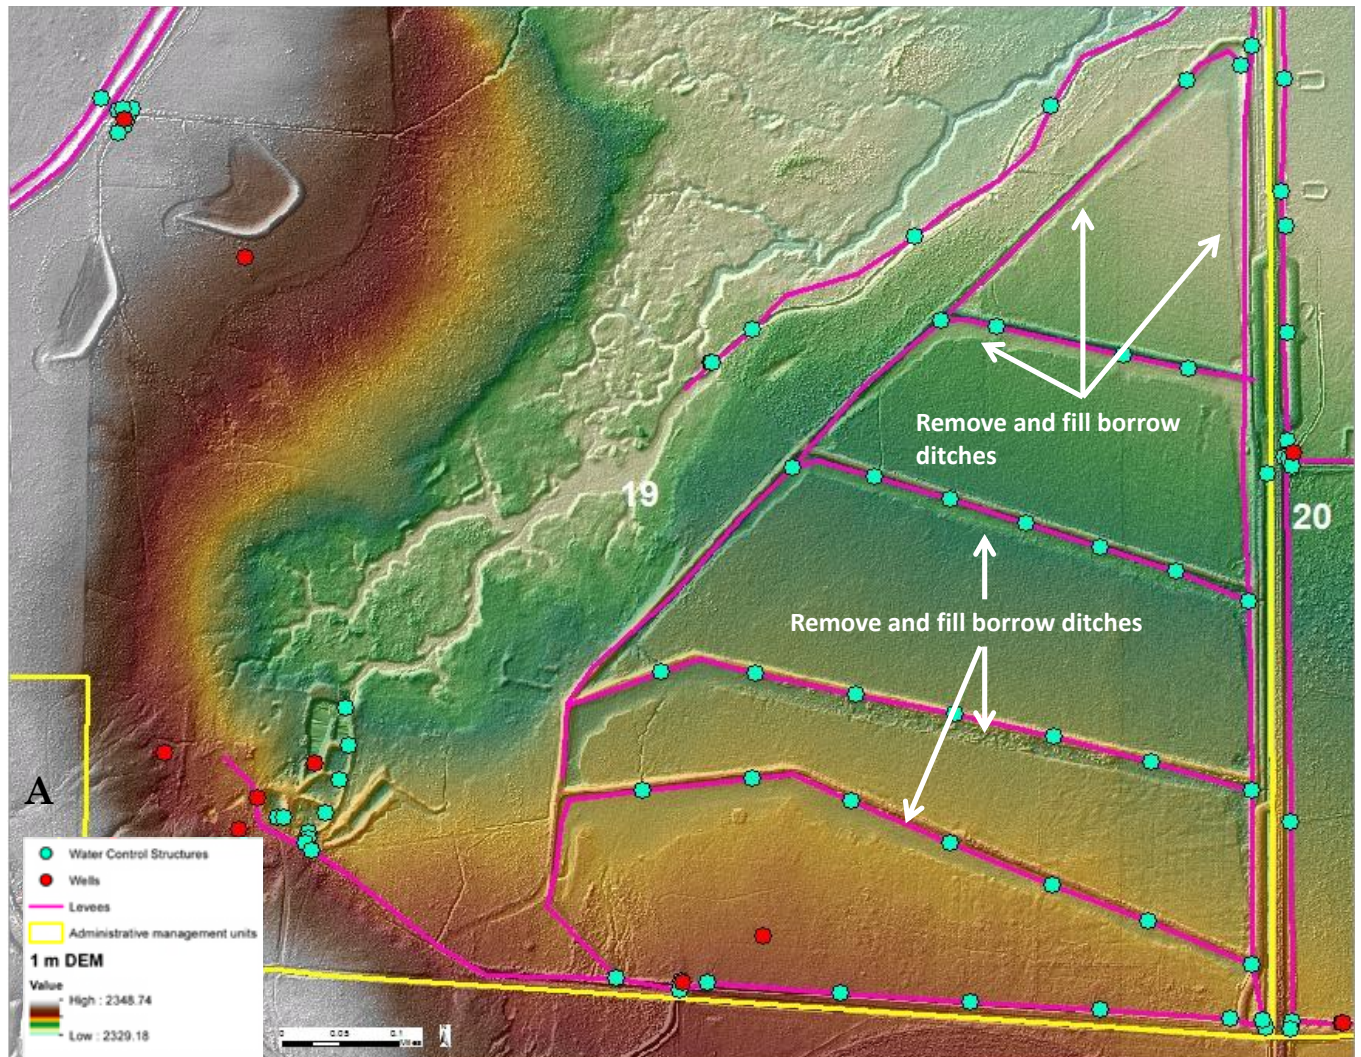
Figure 33a. Potential restoration in Unit 19 indicating elevation gradients, location of water-control structures, and the extent of spring flooding based on typical water management activities. Potential restoration options could include filling deeper borrow areas near dikes with soil to reduce the water required to provide suitable habitat for migrating sandhill cranes. Doing so would increase wetland acres while reducing overall water use in the unit.

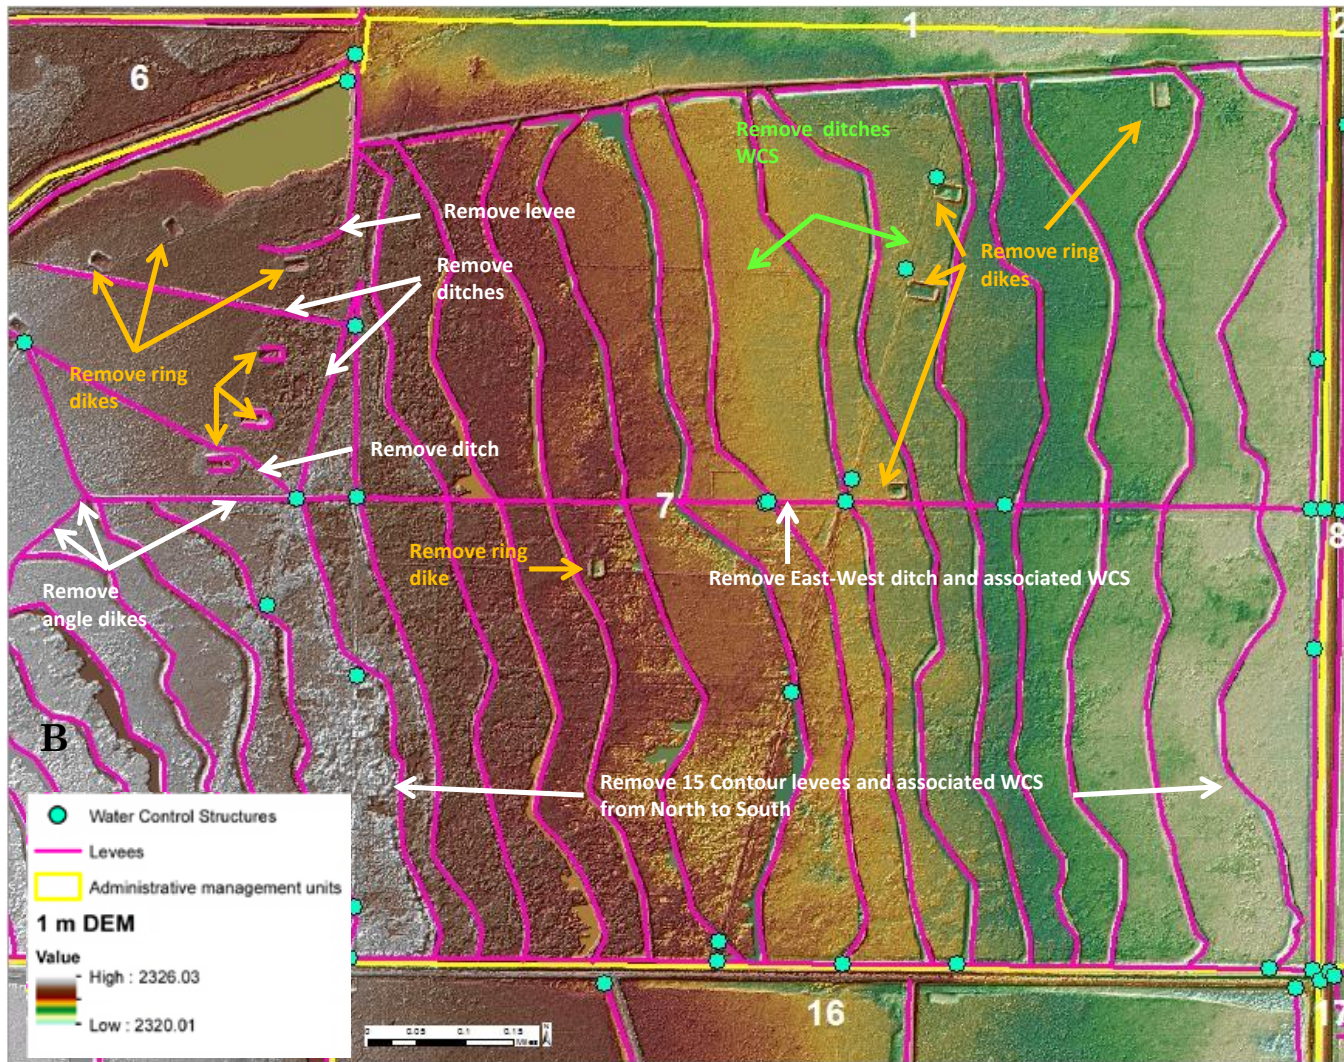
Figure 33b. Potential restoration in Unit 7 indicating locations to remove levees, ring dikes, ditches, and water control structures in order to promote the growth of native vegetation and restore natural hydrologic conditions. Unit 7 was historically dominated by salt desert shrub as indicated by soils, remnant native vegetation communities, and the invasion of weeds. The eastern third contains the most saline soils and represents an area of continued invasive weed expansion such as tall whitetop. Water historically may have overflowed from the creek and sub-irrigated some of these shrublands from the north, however prolonged flooding, tall emergent, and back flooding from east to west was not apparent.

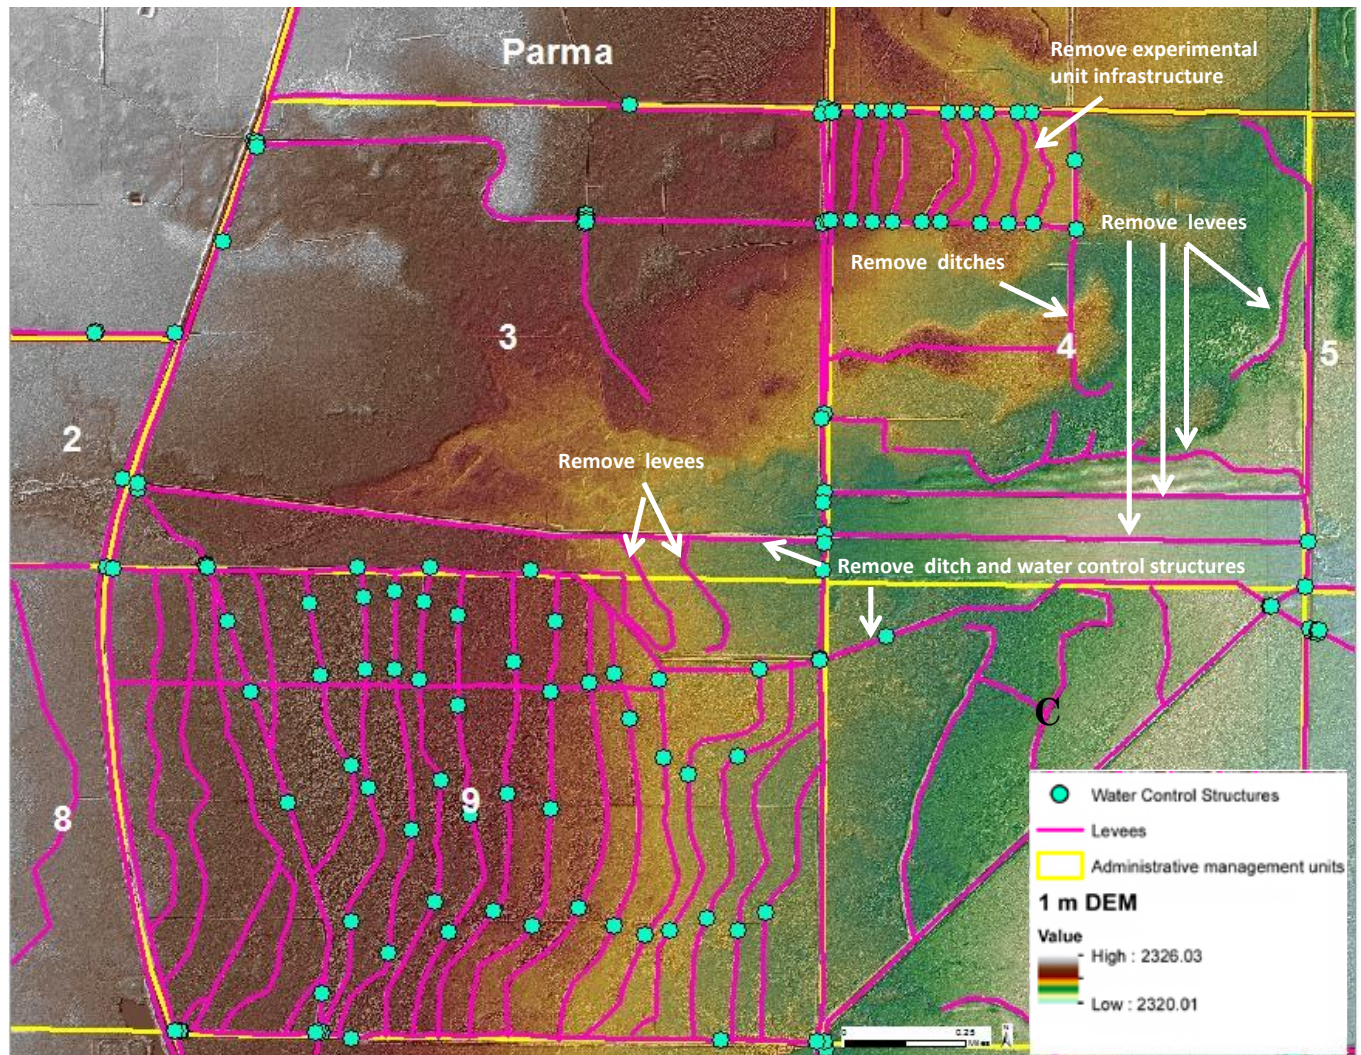
Figure 33c. Potential restoration at the confluence of Spring and Rock Creeks in Units 3, 4, and 9 indicating locations to remove levees, ditches, and water-control structures in order to promote the growth of native vegetation and restore natural hydrologic conditions. The confluence area represents the largest extent of wetland habitat historically present within refuge boundaries as indicated by soils, remnant native vegetation communities, and the GLO map. Water historically may have overflowed from the creek and sub-irrigated some of the areas to the north and south of the creek area.

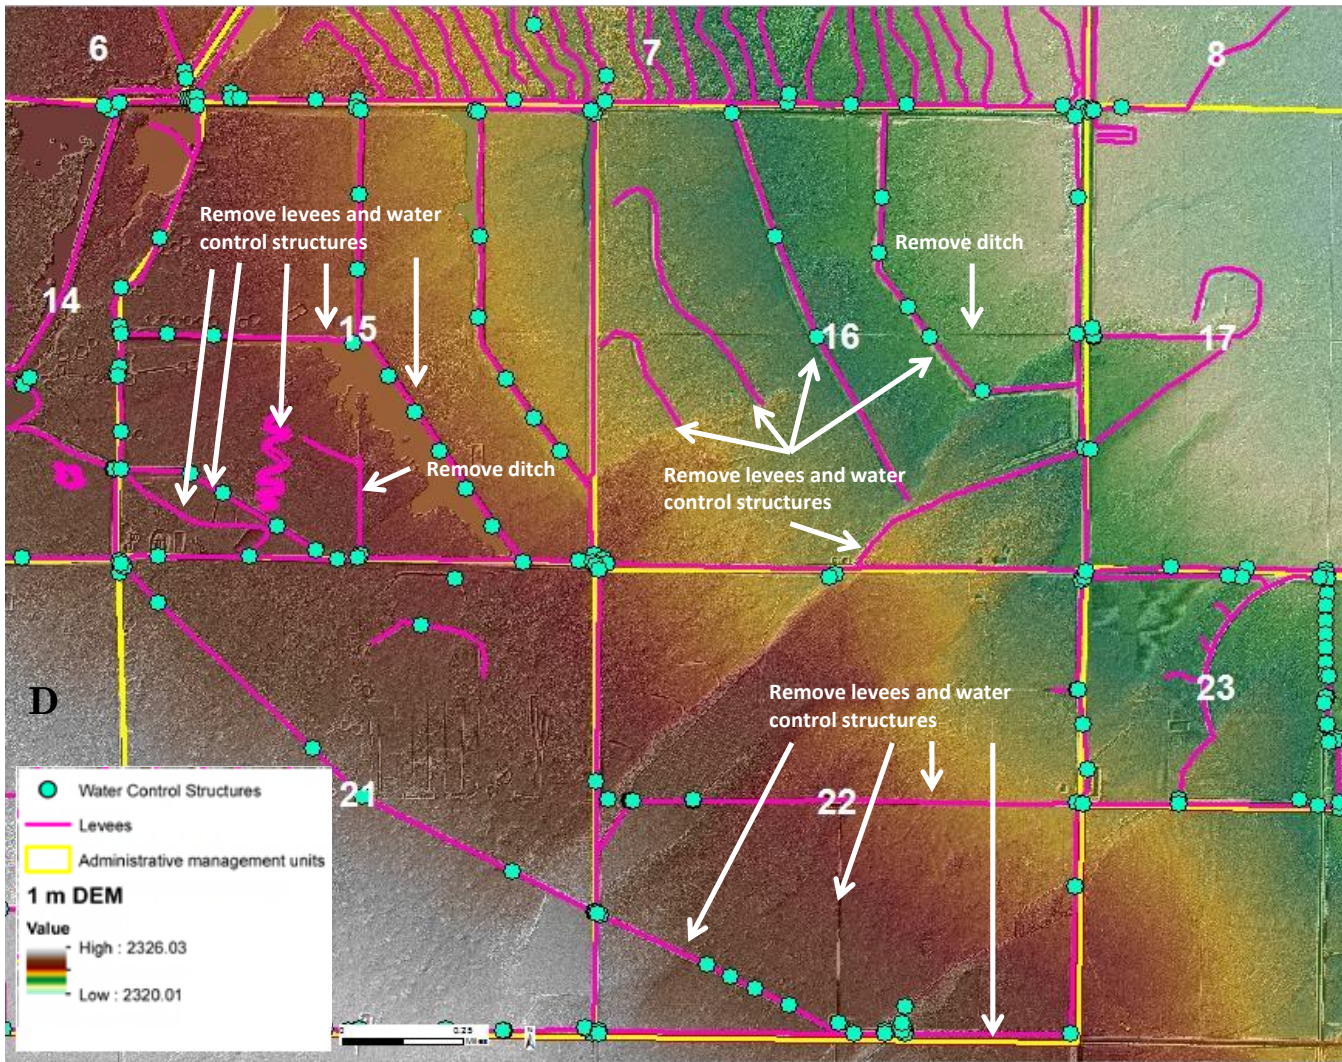
Figure 33d. Potential restoration at the confluence of the terminal portion of Cat Creek in Units 21, 22, and 16 indicating locations to remove levees, ditches, and water-control structures in order to promote the growth of native vegetation and restore natural hydrologic conditions. This area, including Unit 15, was historically a heterogeneous assemblage of wet meadow, salt desert shrub, and saline salt desert shrub as indicated by soils, remnant native vegetation communities, and historical maps and accounts. Tall whitetop is currently a dominant species throughout these units and the Cat Creek corridor. Water historically may have overflowed from the creek and sub-irrigated some of the areas to the east and west of the creek area for short periods of time.
